EMT development as a new MUMON sensor

Kiseki Nakamura (Tohoku)

2023/04/13

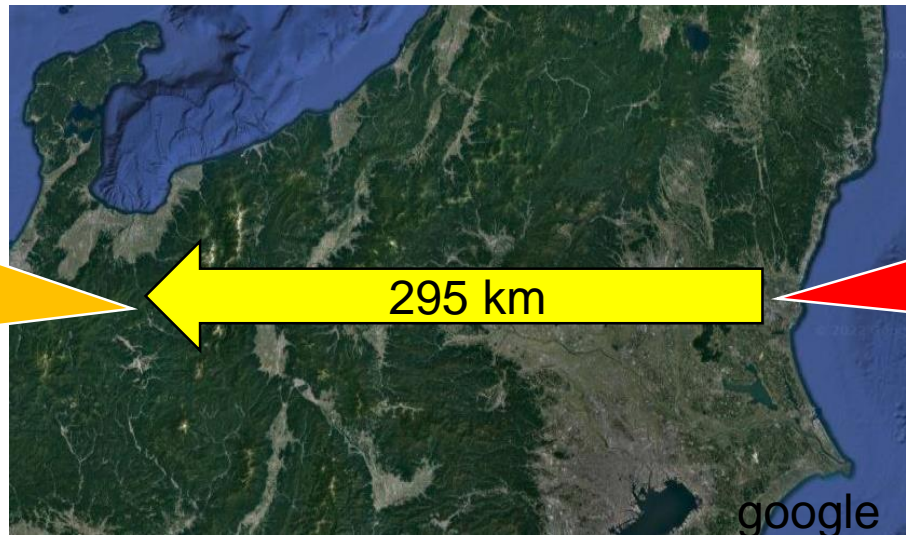
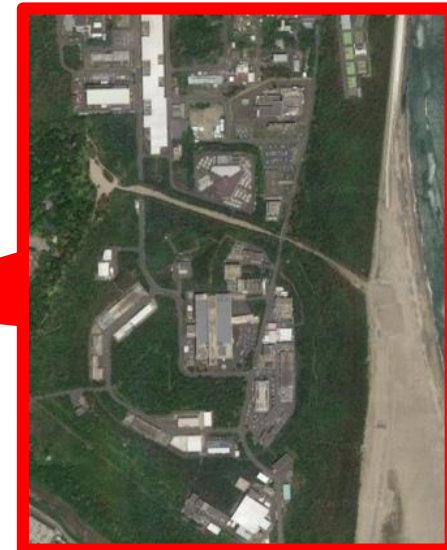
- Long baseline neutrino oscillation experiment
- Produce ν_μ or $\bar{\nu}_\mu$ at J-PARC and detect neutrinos after oscillation at SK
- Search for CP violation in the lepton sector
- Beam power is gradually increased (current 500 kW, plan 1.3 MW)

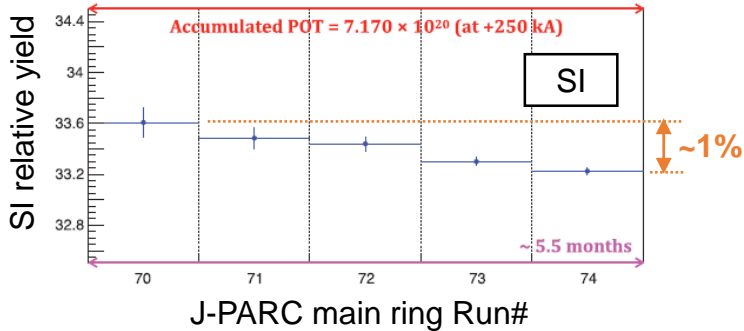
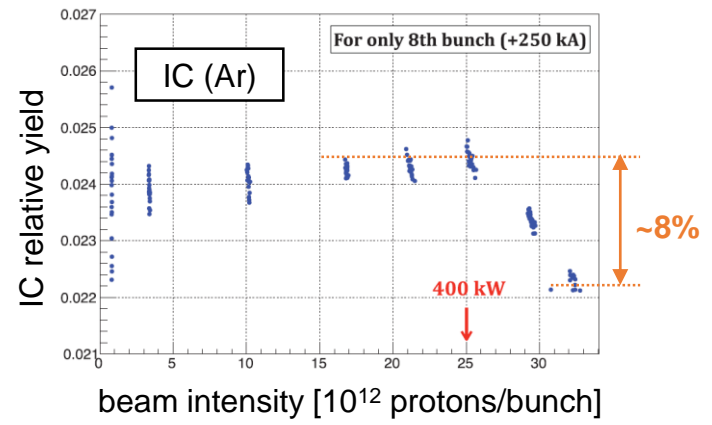
- Known Issue for high intensity beam
 - SI : yield decrease due to radiation damage
 - IC : signal saturation in higher intensity

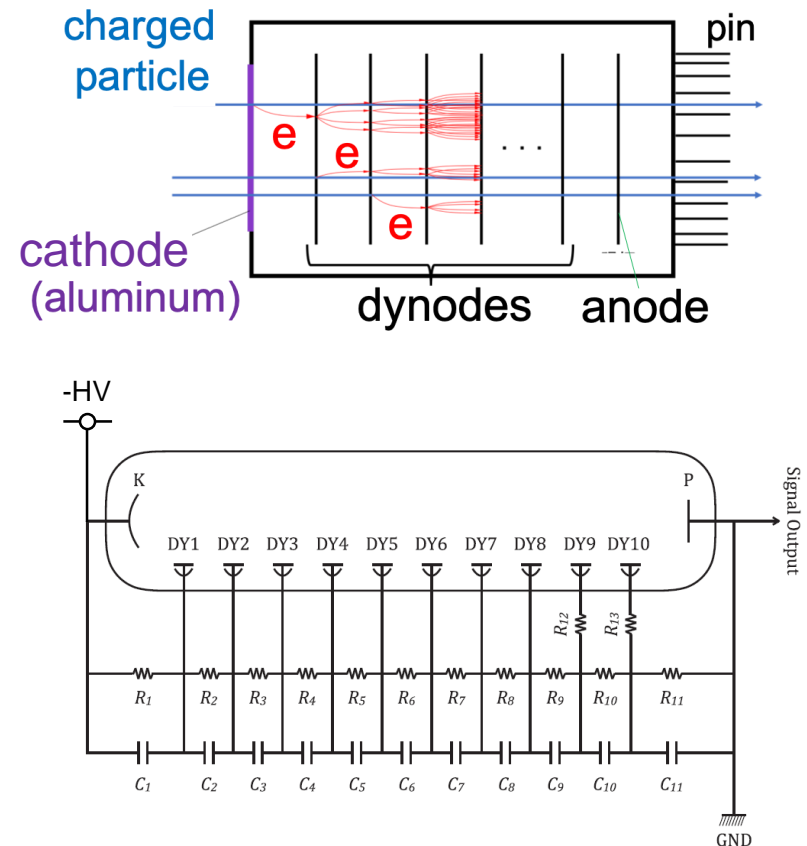
EMT: electron multiplier tube

- Next candidate sensor for MUMON
- similar to PMT, but Al is deposited on the cathode
- secondary electrons are produced by charged particles at cathode and dynodes

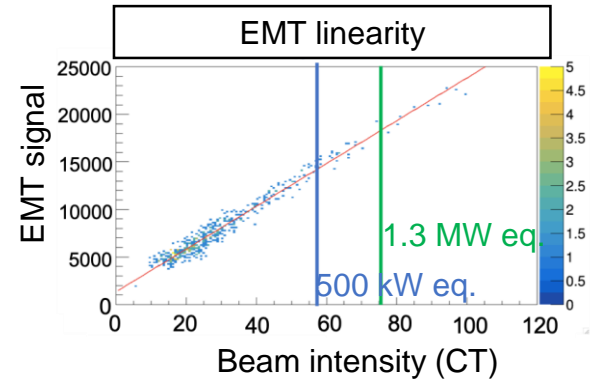
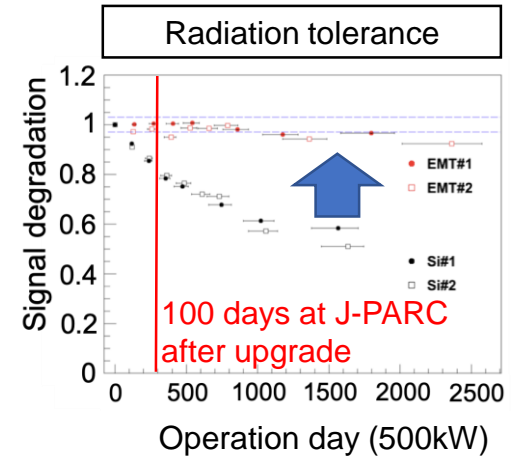
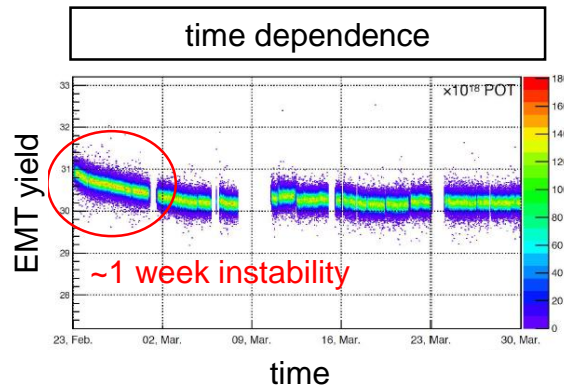
Previous beam test results

- 1st ELPH (linac electron) beam test
 - Linearity for high intensity is OK
- 2nd ELPH (linac electron) beam test
 - Radiation tolerance of EMT is much better than that of SI
- T2K beam at MUMON-pit
 - succeeded to install and take data
 - initial instability (~1 week yield decrease) was seen
 - instabilities were seen after beam stop

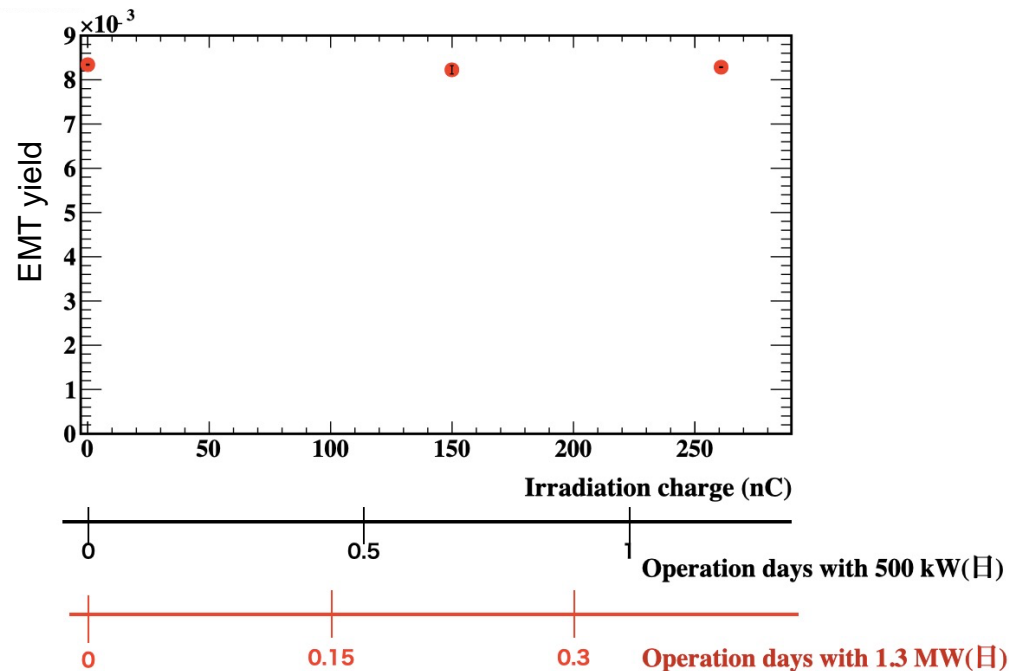
Initial instability (3rd beam test)

- Initial instability is not seen in ELPH beam test
- Different from the measurement at J-PARC
- This time, we took data 30 min after HV applied
- Temperature dependence was seen at J-PARC?

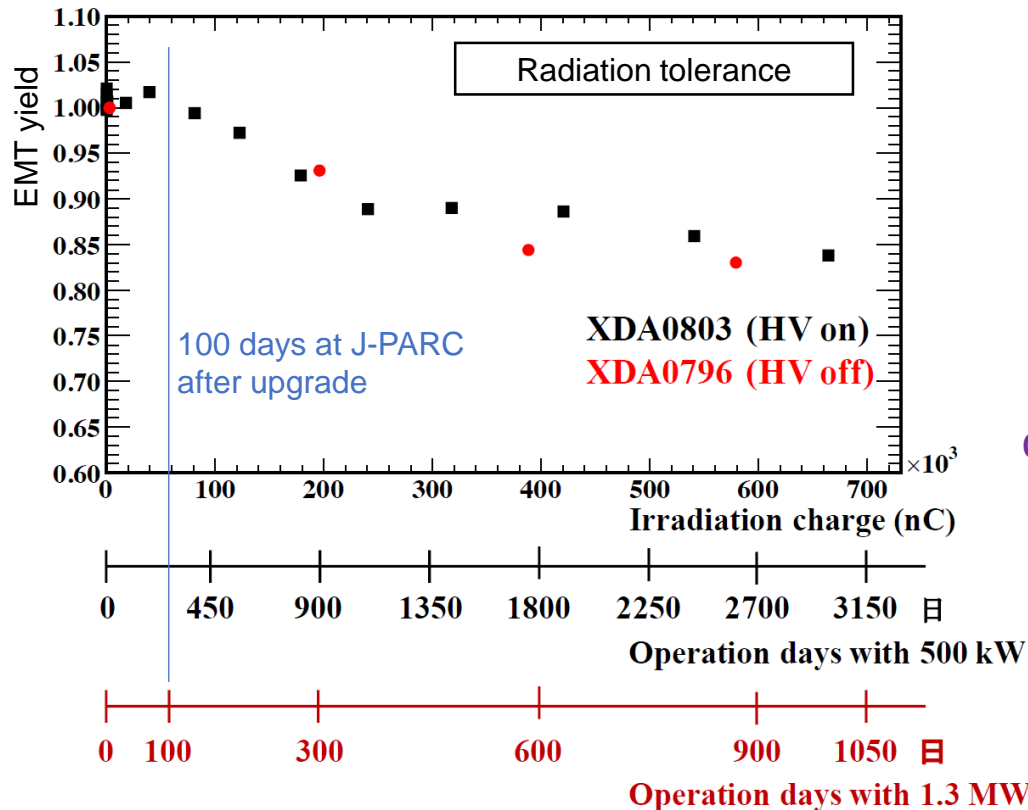
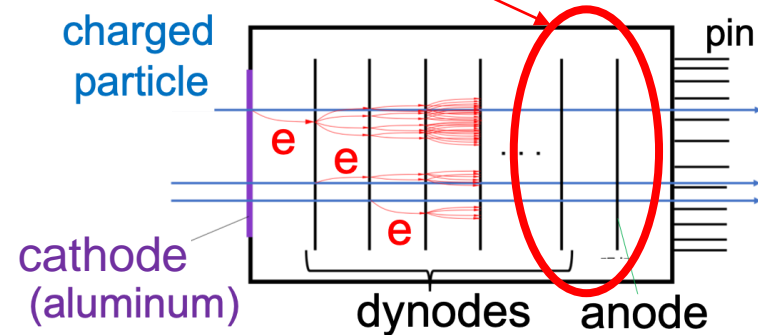
Radiation tolerance: last dynode

- OK for 100 days operation in 1.3 MW beam
- Signal yield decreased for large irradiation
- Even irradiated with HV off, signal decreased
 - "too much electron multiplication at the dynode" is not the main cause of damage

- The following hypotheses were **rejected**
 - **last dynode** is damaged by too much electron multiplying process
 - **circuit** (resistor or capacitor) is damaged
 - **cathode** (aluminum is deposited) is damaged
- Remaining possibility
 - **dynodes** (antimony is deposited) are damaged by radiation
 - very first stage of R&D, w/o antimony EMT was tested --> gain was too small
- We isolated the cause of EMT deterioration and confirmed the best way to use it

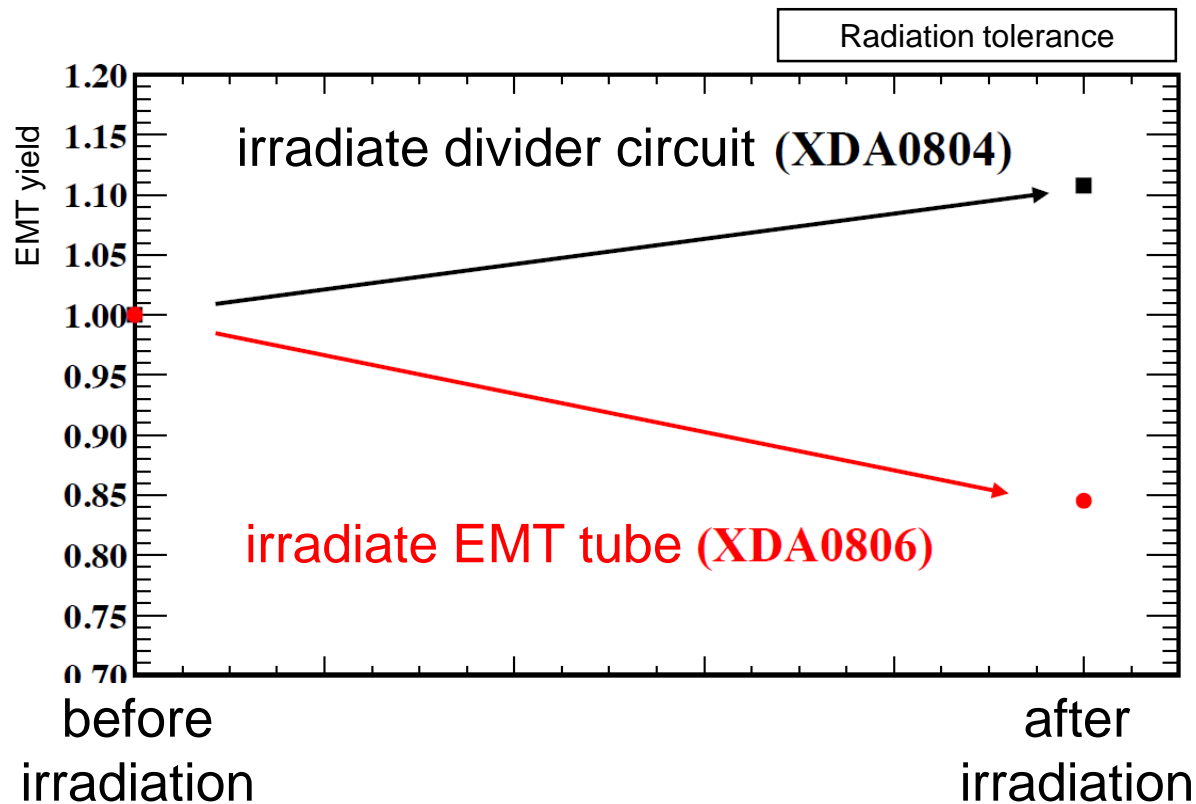
Radiation tolerance: circuit

- Irradiate to the breeder circuit and EMT individually
- breeder circuit irradiation: signal yield increased a little
- EMT tube irradiation: signal yield decreased
 - EMT tube itself is damaged

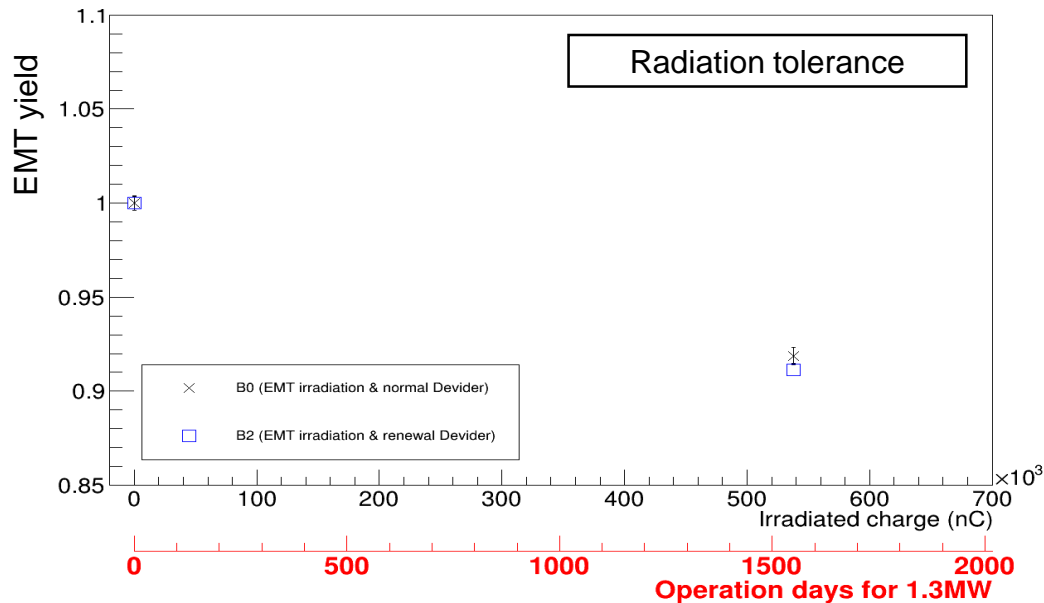
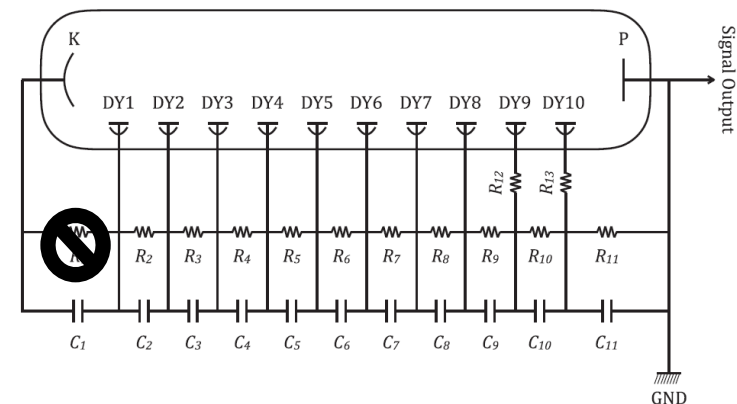
Radiation tolerance: cathode

- Special breeder circuit
 - Resistor between cathode and first dynode is set to 0 ohm
 - Cathode does not contribute to signal --> we can check the damage from other part separately
- Result
 - despite of using special breeder circuit, signal yield decreased

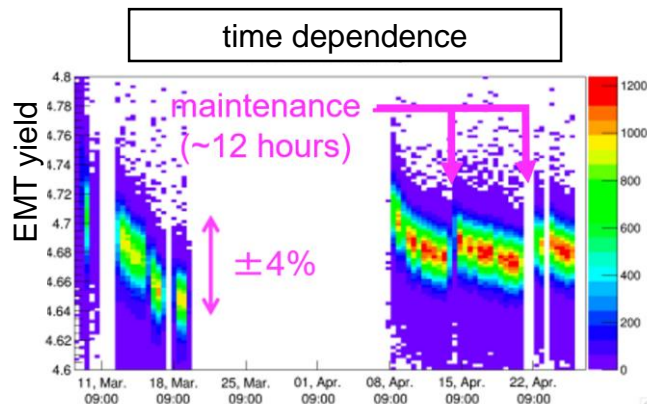
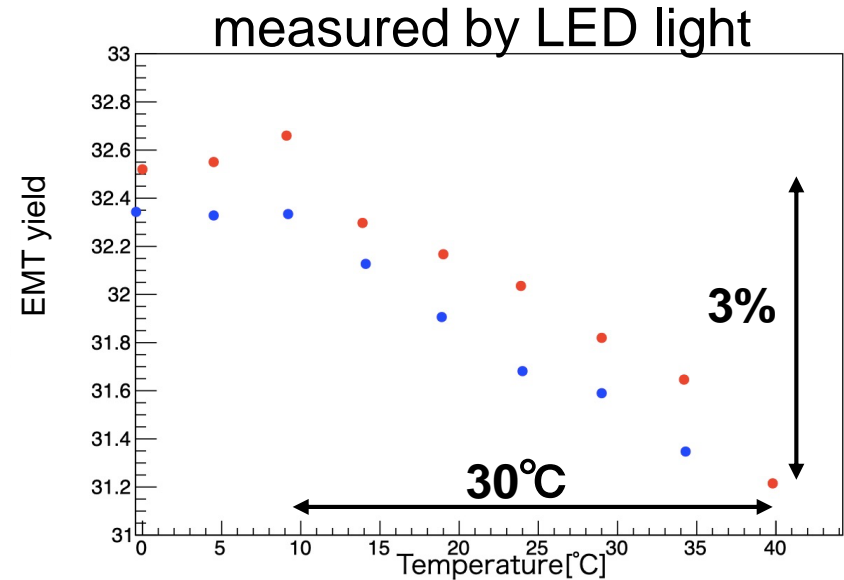
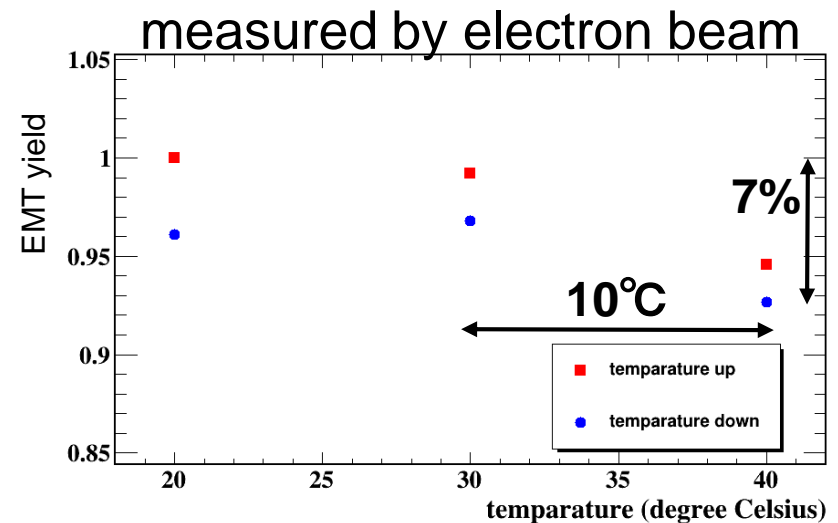
Temperature dependence

- Measured by LED light
 - about $0.1\%/^{\circ}\text{C}$ of signal decrease
 - Equivalent temperature change is 40°C at MUMON-pit, a bit unlikely
- Measured by electron beam
 - about $0.7\%/^{\circ}\text{C}$ of signal decrease
 - Equivalent temperature change is 6°C
 - --> This could be the case at the MUMON-pit when accelerator is turned on

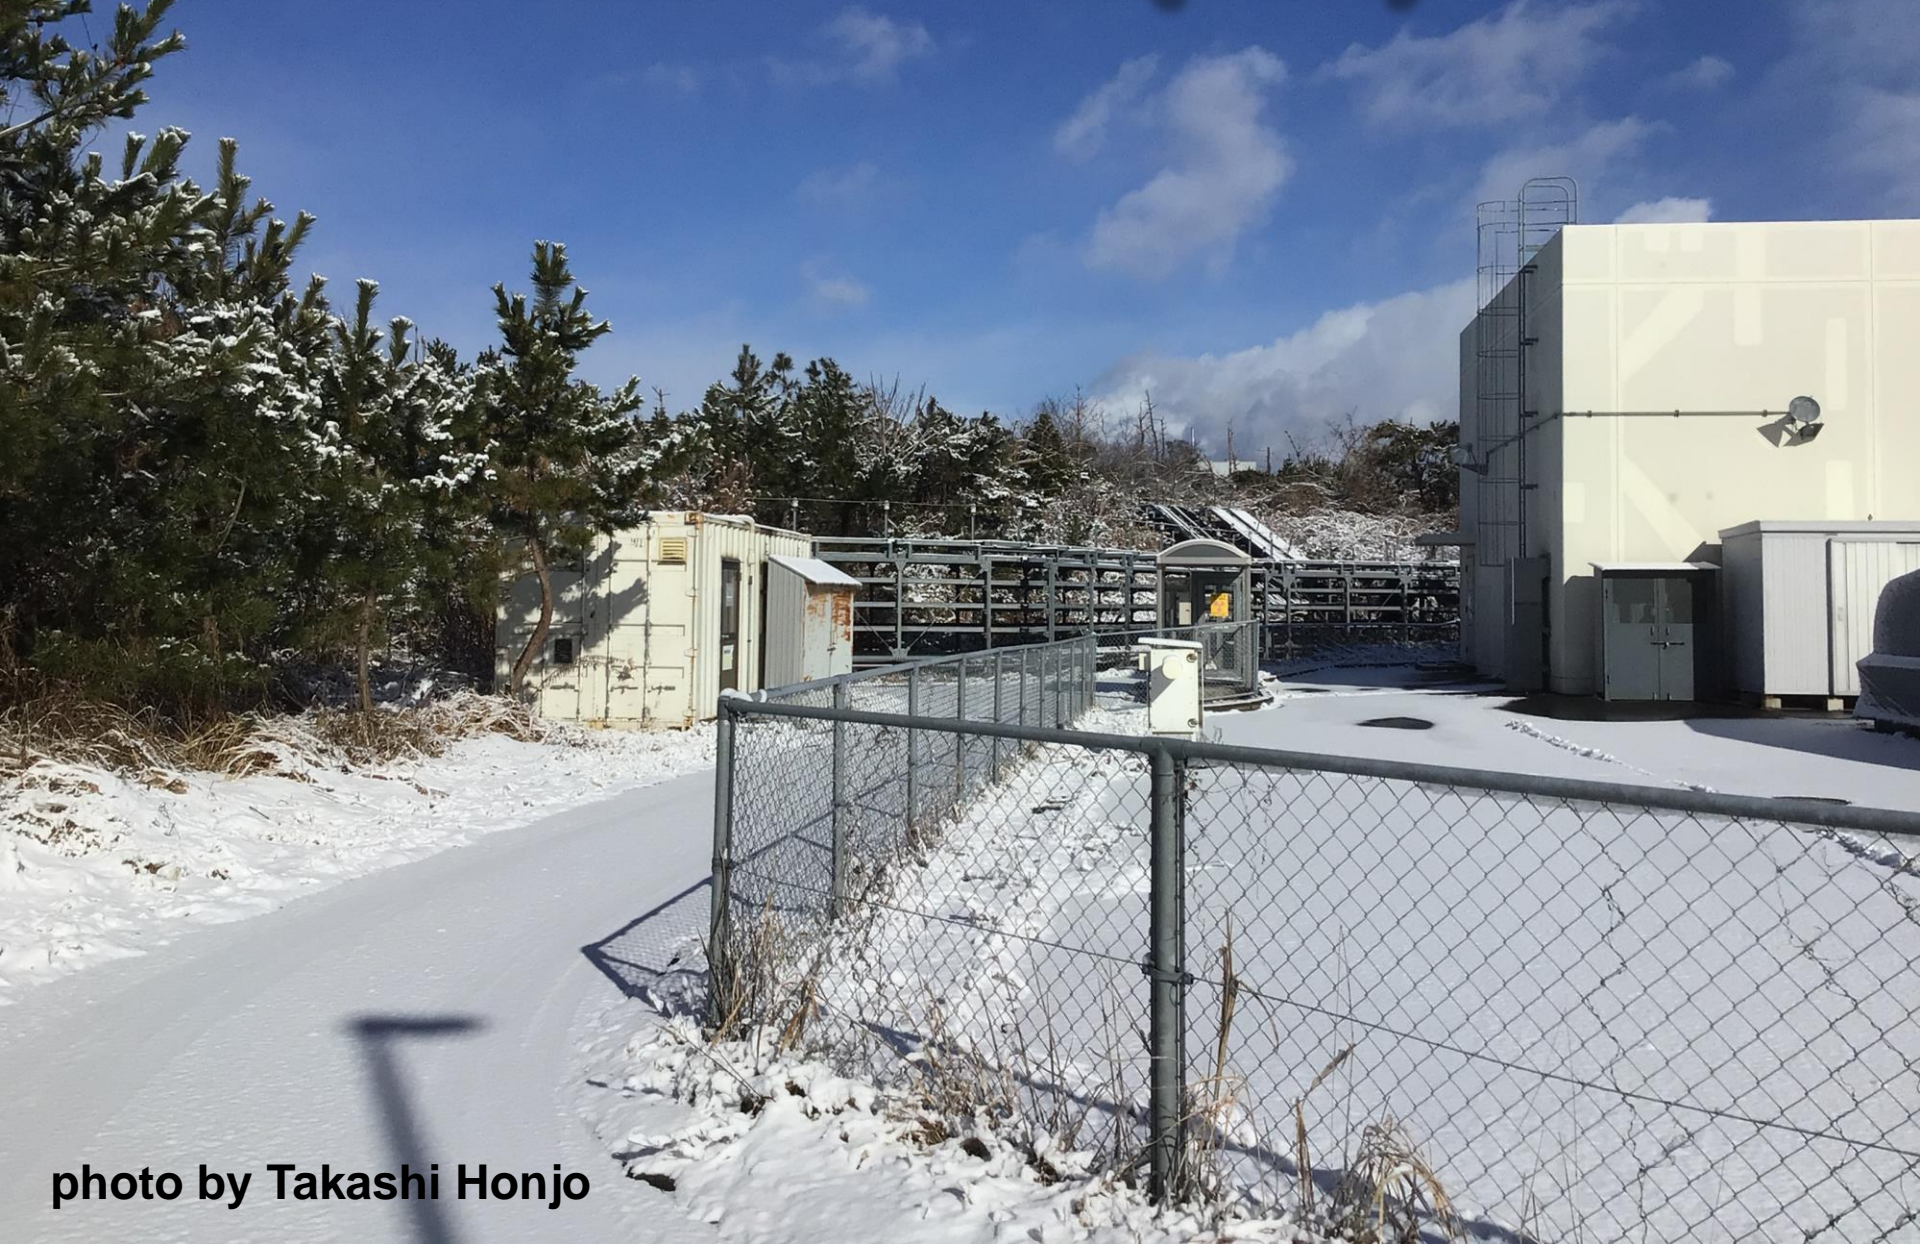
Next T2K beam: RUN12 (2023)

EMT installation
