### Exhaust valve spindles for marine diesel engines manufactured by hot isostatic pressing

Alberto Lapina, Harro Andreas Hoeg, Jakob Knudsen MAN Diesel & Turbo Tomas Berglund Sandvik Powder Solutions Rune Møller, Jesper Henri Hattel Technical University of Denmark

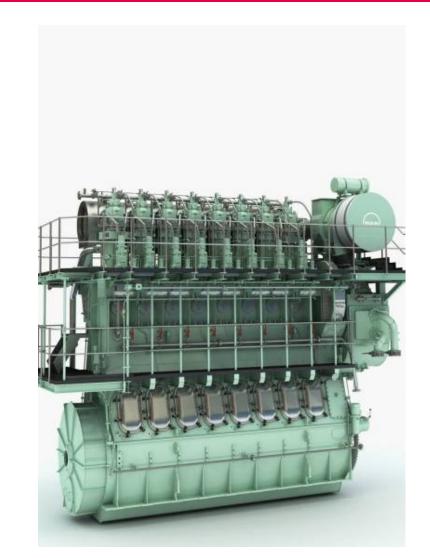
## The solution to challenge nr. 1: the two-stroke diesel engine

- Well-proven technology
- High efficiency
- Wide range of possible fuels (heavy fuel oil, diesel oil, natural gas, ethane, methanol, etc.)
- 3-80 MW power range depending on engine model

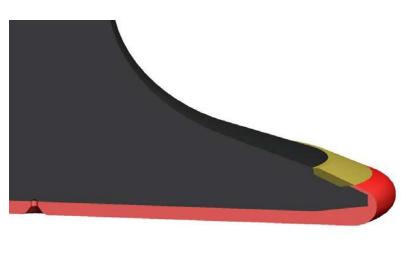
### The current solution to problem 2: the Duraspindle<sup>™</sup>

- Stainless steel substrate
- Inconel 718 seat: high hardness after aging and cold deformation → good wear resistance
- Inconel 625 bottom coating: high hot corrosion resistance
- Max allowed corrosion rate: 0. 4 mm/ 1000 hrs
